SUBJECT: Lower Cascade Canal and Upper Grass Valley Canal Tree Health, Canopy Cover and Pond Monitoring Report – Year 8 (Project # 6593-2)

**Banner Cascade Pipeline Project
Tree Health, Canopy Cover, and
Pond Monitoring Report – Year 8**

Tree Health, Canopy Cover, and Pond
Monitoring Report – Year 8

Lower Cascade, Upper Grass Valley,
and DS Canals

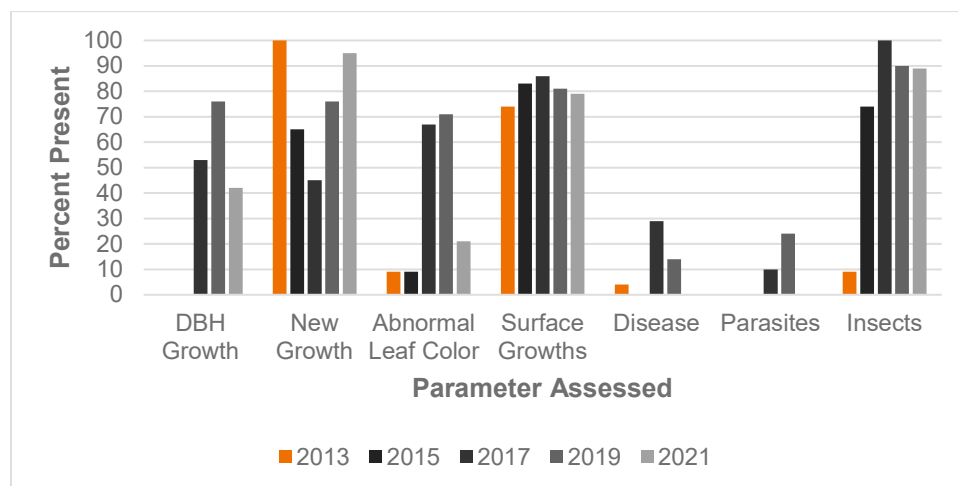
Graph 4-1 Lower Cascade Canal Site 1 Tree Health Assessment Data

In Monitoring Year 8, 19 riparian trees were surveyed at Site 1 on LCC on September 20, 2019, including bigleaf maple, Pacific dogwood, and gray alder. Three new dead trees were found. Most trees surveyed had full to partial canopy cover and good bark health, and exhibited DBH growth, new growth, surface growths, foliage discoloration, and insect damage. Disease was minimal at this site, but a few tree trunks were encroached by parasites such as honeysuckle and poison oak. Overall tree health at Site 1 is good, with a range of health scores from 8 to 14 and an average health score of 10 (Table 4-1, Graph 4-1).

Since Baseline Year 0, trees at Site 1 improved from partial to medium canopy cover, and bark health remained good. However, presence of abnormal leaf color and insects increased from barely present at Site 1 to present in most trees. Presence of new growth greatly decreased from Baseline Year 0 to Monitoring Year 4 but made a substantial recovery in Monitoring Year 6 and sustained that into Monitoring Year 8. Surface growth remained highly prevalent and diseases and parasites remained minimal across monitoring years, though honeysuckle and other parasitic plants were observed in increasing quantity at Site 1. Two tree deaths were observed at Site 1 between Baseline Year 0 and 6, and three new trees were confirmed dead in Monitoring Year 8. In comparison with Monitoring Year 6, trees surveyed in Monitoring Year 8 exhibited overall improvements in DBH and new growth, as well as less disease. Overall tree health at Site 1 remains good since Baseline Year 0, oscillating on health between Monitoring Years 2 through 8 (Table 4-1, Graph 4-1). Although three new trees were found dead, the other surviving trees are showing better health at this site as compared to the previous two monitoring years. The three trees that died were previously in the “fair health” category and had been declining over the years.

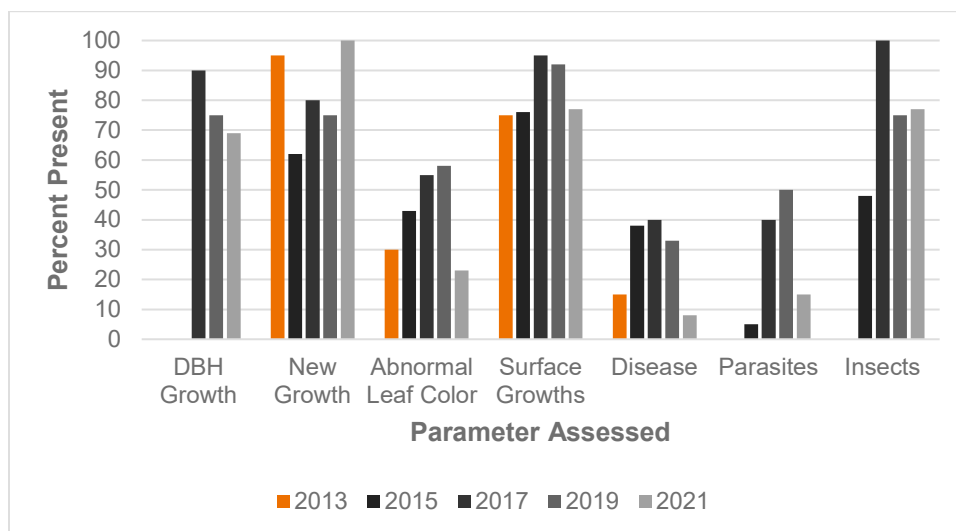
Graph 4-2. Lower Cascade Canal Site 2 Tree Health Assessment Data

During Year 8 monitoring, 13 riparian trees were surveyed at Site 2 on LCC on September 15, 2021. Tree species surveyed include bigleaf maple, gray alder, and Pacific dogwood. No new trees were found dead. Most trees surveyed had full to partial canopy cover and good bark health, and exhibited new growth, surface growths, and insect damage and infestation. Disease was minimal at this site, but approximately half the trees surveyed exhibited foliage discoloration and parasites such as honeysuckle and Himalayan blackberry (*Rubus armeniacus*) on trunks and branches. Overall tree health at Site 2 is good, with a range of health scores from 8 to 13 and an average health score of 10 (Table 4-2, Graph 4-2).

General site conditions included excessive encroachment by non-native understory species (e.g., Himalayan blackberry), as noted in previous years. Mechanical removal of upslope study trees in 2018 and installation of fencing by private landowners rendered the upslope portion of the site unable to be surveyed. As such the upslope trees are no longer a part of the study. Drainage fed by LCC and rainfall/runoff was observed near trees surveyed downslope of LCC; it did not have water at the time of the survey this year. Various upland tree species are also present at Site 2, including black oak, beaked hazelnut, and incense cedar.

Since Baseline Year 0, canopy cover of trees at Site 2 remained consistent, and bark health varied over the years but remained in the good health category in Monitoring Year 8. DBH growth has steadily declined since Baseline Year 0, however new growth has oscillated over the years and increased in Monitoring Year 8. Abnormal leaf color, surface growths, diseases, and parasites decreased during Monitoring Year 8, however insect presence increased. Only one tree death was observed at Site 2 since Baseline Year 0, and no new trees were confirmed dead in Monitoring Year 8. In comparison with Monitoring Year 6, trees surveyed in Monitoring Year 8 exhibited improvements in new growth, less abnormal leaf color, surface growth, disease, and parasites. However, there was an increased presence of insects and insect damage and less evidence of DBH growth. Overall tree health at Site 2 remains good since Baseline Year 0, with a slight decrease between Monitoring Years 2 through 6 (Table 4-2, Graph 4-2), but increasing in Monitoring Year 8.

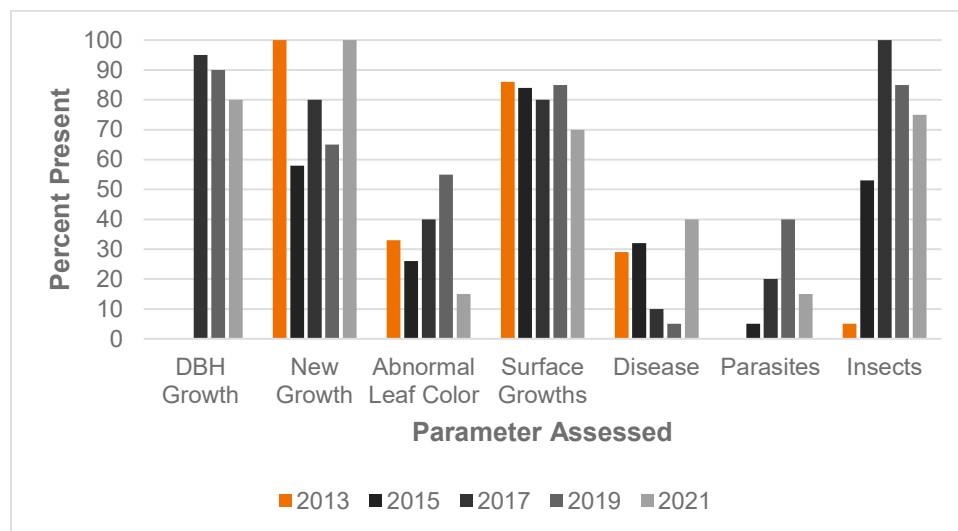
Graph 4-3. Lower Cascade Canal Site 3 Tree Health Assessment Data

During Monitoring Year 8, 20 riparian trees were surveyed at Site 3 on LCC on September 15, 2021. Tree species surveyed include bigleaf maple, gray alder, and Pacific dogwood. No new trees were found dead. Most trees surveyed had full to partial canopy cover and good bark health. Trees exhibited some surface growth, in the presence of and insect damage and infestation. Over half the trees surveyed exhibited new growth. Disease amongst some of the trees was observed at this site, in addition to parasites such as California wild grape and english ivy present on several tree trunks and branches. Little abnormal leaf color was observed. Overall tree health at Site 3 is good, with a range of health scores from 4 to 14 and an average health score of 10 (Table 4-3, Graph 4-3).

General site conditions included encroachment by non-native and invasive understory species that also were vining up the tree trunks (e.g., English ivy). Various upland tree species are also present at Site 3, including Douglas-fir and incense cedar.

Since Baseline Year 0, trees at Site 3 improved from partial to medium canopy cover, as well as fair to good bark health. However, between Monitoring Year 6 and Monitoring Year 8, more disease was detected throughout the trees. The presence of new growth declined over the years, but rebounded this year and abnormal leaf color and parasites declined as compared to the last monitoring year. Presence of insects also increased from barely present at Site 3 to present in a majority trees, though the prevalence of insect damage dropped in Monitoring Years 6 and 8. Surface growths remained highly and consistently prevalent, although slightly decreased this year. No tree deaths were observed at Site 3 since Baseline Year 0. In comparison with Monitoring Year 6, trees surveyed in Monitoring Year 8 exhibited

improvements in the presence insect damage, parasites, new growth, and abnormal leaf color. The trees surveyed exhibited greater presence of disease, as well as less evidence of DBH and new growth. Overall tree health at Site 3 remained consistently good, even increasing slightly in Monitoring Year 8 (Table 4-3, Graph 4-3).

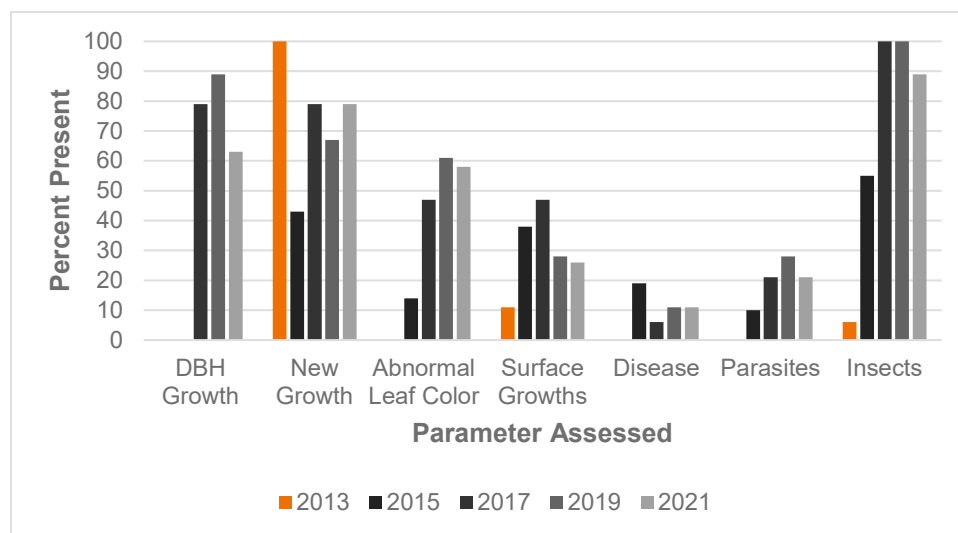
Graph 4-4. Lower Cascade Canal Site 4 Tree Health Assessment Data

During Year 8 monitoring, 19 riparian trees were surveyed at Site 4 on LCC on September 14, 2021. Tree species surveyed include bigleaf maple, gray alder, and Oregon ash. No new trees were found dead. Most of the trees surveyed exhibited insect damage and infestation. On average, trees surveyed had full to partial canopy cover and good bark health, and over half the trees surveyed exhibited new growth and foliage discoloration. Disease, surface growth, and parasites were minimal at this site, though english ivy and root rot were present on some tree trunks. Overall tree health at Site 4 is good, with a range of health scores from 4 to 14 and an average health score of 10 (Table 4-4, Graph 4-4).

Since Baseline Year 0, trees at Site 4 remained consistent in partial to full canopy cover and good bark health. However, presence of new growth declined, and abnormal leaf color and insects increased from barely present at Site 4 to present in most to all trees. Surface growths, diseases, and parasites remained low but also generally increased since Baseline Year 0, though the prevalence of surface growth and parasites dropped in Monitoring Year 8. No new tree deaths were observed. In comparison with Monitoring Year 6, trees surveyed in Monitoring Year 8 exhibited improvements in the presence of new growth, insect damage, and parasites, but also exhibited less evidence of DBH growth. Overall tree health at Site 4 decreased from excellent to good since Baseline Year 0, but remained consistently good between Monitoring Years 2 through 8, although exhibiting a slight decrease over the monitoring years (Table 4.4, Graph 4-4).

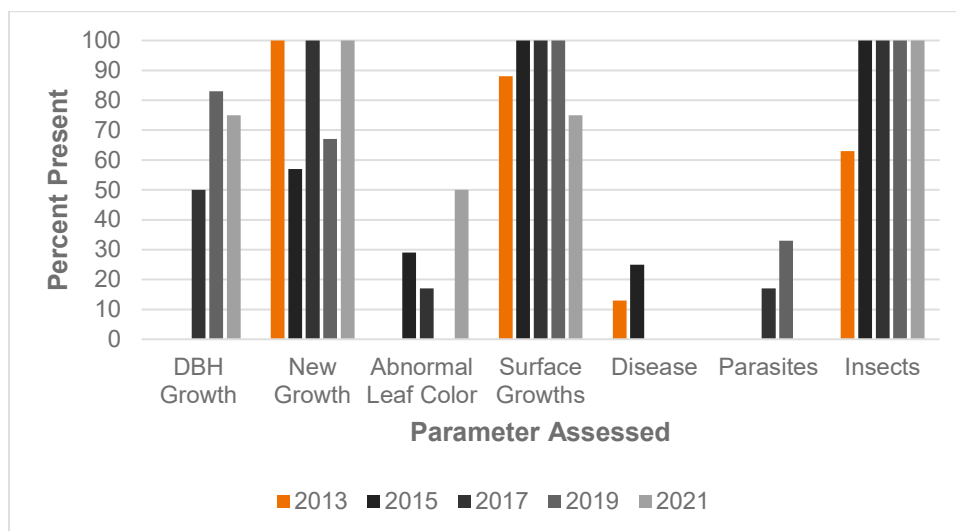
Graph 4-5. Upper Grass Valley Canal Site 5 Tree Health Assessment Data

During Year 8 monitoring, four riparian trees were surveyed at Site 5 on UGVC on September 15, 2021. Tree species surveyed include bigleaf maple, Pacific dogwood, and white alder. Two trees appeared to have been mechanically removed for road maintenance. All trees surveyed exhibited insect damage and infestation, but also new growth. Most trees surveyed exhibited full to partial canopy cover, excellent bark health, and no disease. There was a presence of abnormal foliage discoloration. Parasitic honeysuckle was present on some tree trunks and adjacent saplings. Mechanical damage to trees from roadside tree-trimming was observed, as well as new growth of various riparian tree species saplings within the site.

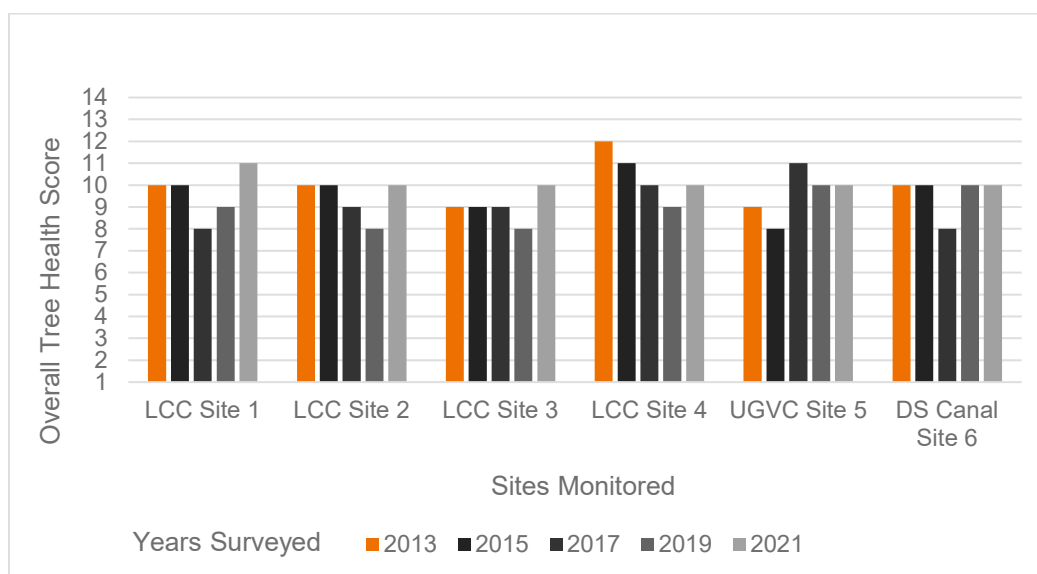
Graph 4-7. Average Overall Tree Health Scores⁷ by Study Site

Overall tree health at Sites 1, 2, 3, and 4 on LCC increased from Monitoring Years 6 to 8 (Graph 4-7). Overall tree health at Sites 2, 3, and 4 on LCC was consistent with sites on the other two canals (i.e., UGVC and DS Canal) and higher at Site 1 than any of the other sites. Decreased growth in DBH as compared to previous years was the only negative factor amongst the sites in Monitoring Year 8 as compared to previous years. Otherwise, canopy cover remained consistent at all sites, so it can be

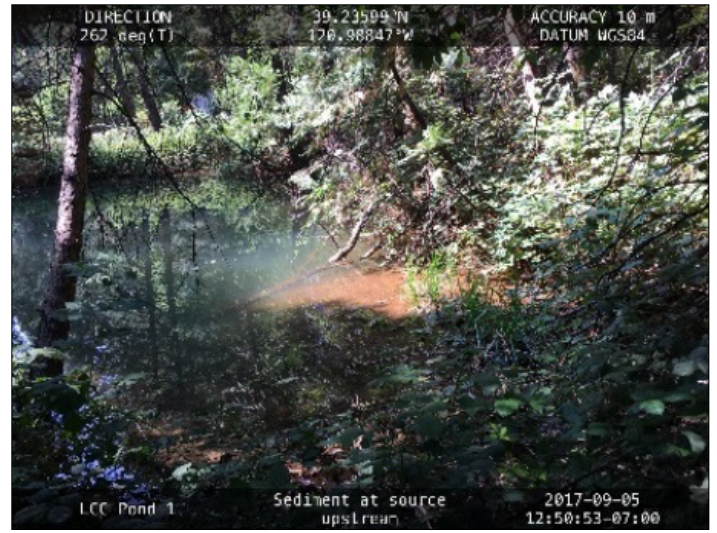
Photograph 44: 9/5/2017. LCC Pond 1. Southwest facing aspect. Sedimentation present from inlet.

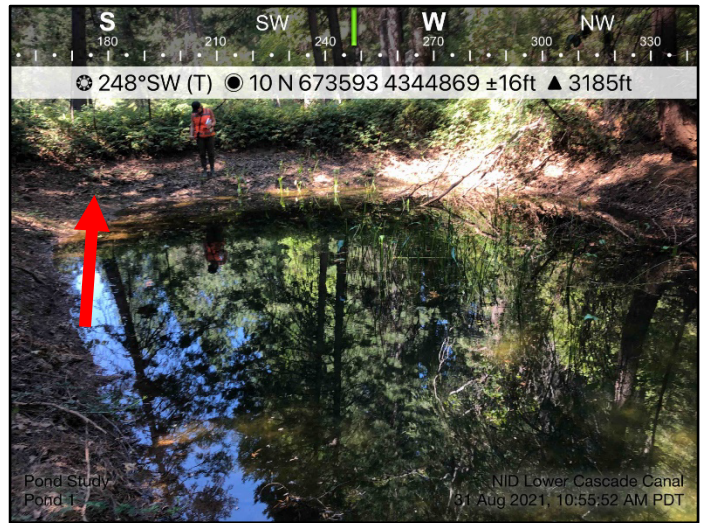
Photograph 46: 2021: LCC Pond 1. Southwest facing aspect. Red arrow indicates the location of the 6-inch culvert connecting Pond 1 and Pond 2 during higher water levels.
