**Lower Cascade Canal and
Upper Grass Valley Canal
Long Term Canopy Cover and
Pond Study Report- Monitoring
Year 4**

Banner Cascade Pipeline Project

Prepared for:
Nevada Irrigation District
1036 West Main Street
Grass Valley, CA 95945

Prepared by:
Stantec Consulting Services Inc.
101 Providence Mine Rd., St. 202
Nevada City, CA 95959

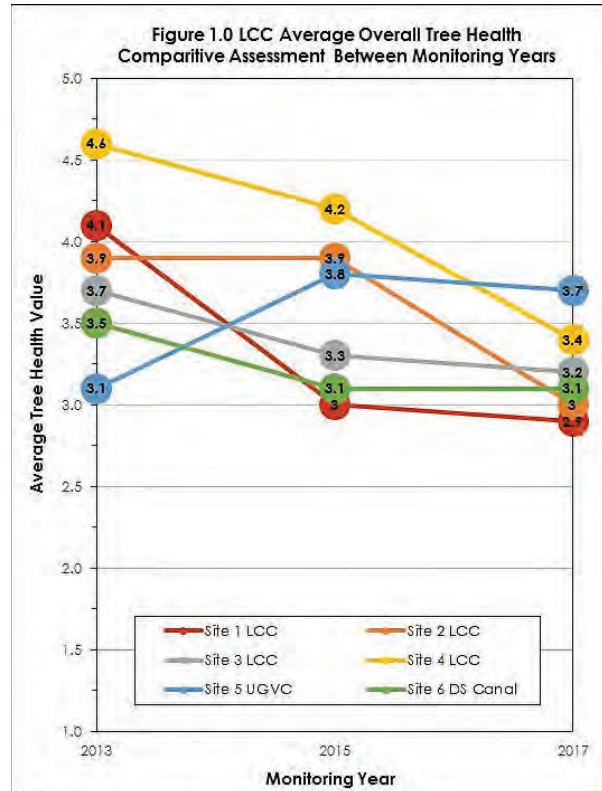
Overall tree health was calculated using all metric variables listed above. All LCC sites (i.e., 1, 2, 3, and 4) yielded an overall decline in average tree health from previous monitoring Year 0 and Year 2 (i.e., 2013 and 2015) (Figure 1.0). This tree health decline was also true of the DS Canal control-site. The two Tree Health Assessment monitoring metrics predominantly contributing to the overall decline in overall tree health are the increase in insect infestations (documented statewide) and observations of leaf discoloration and other foliage abnormalities.

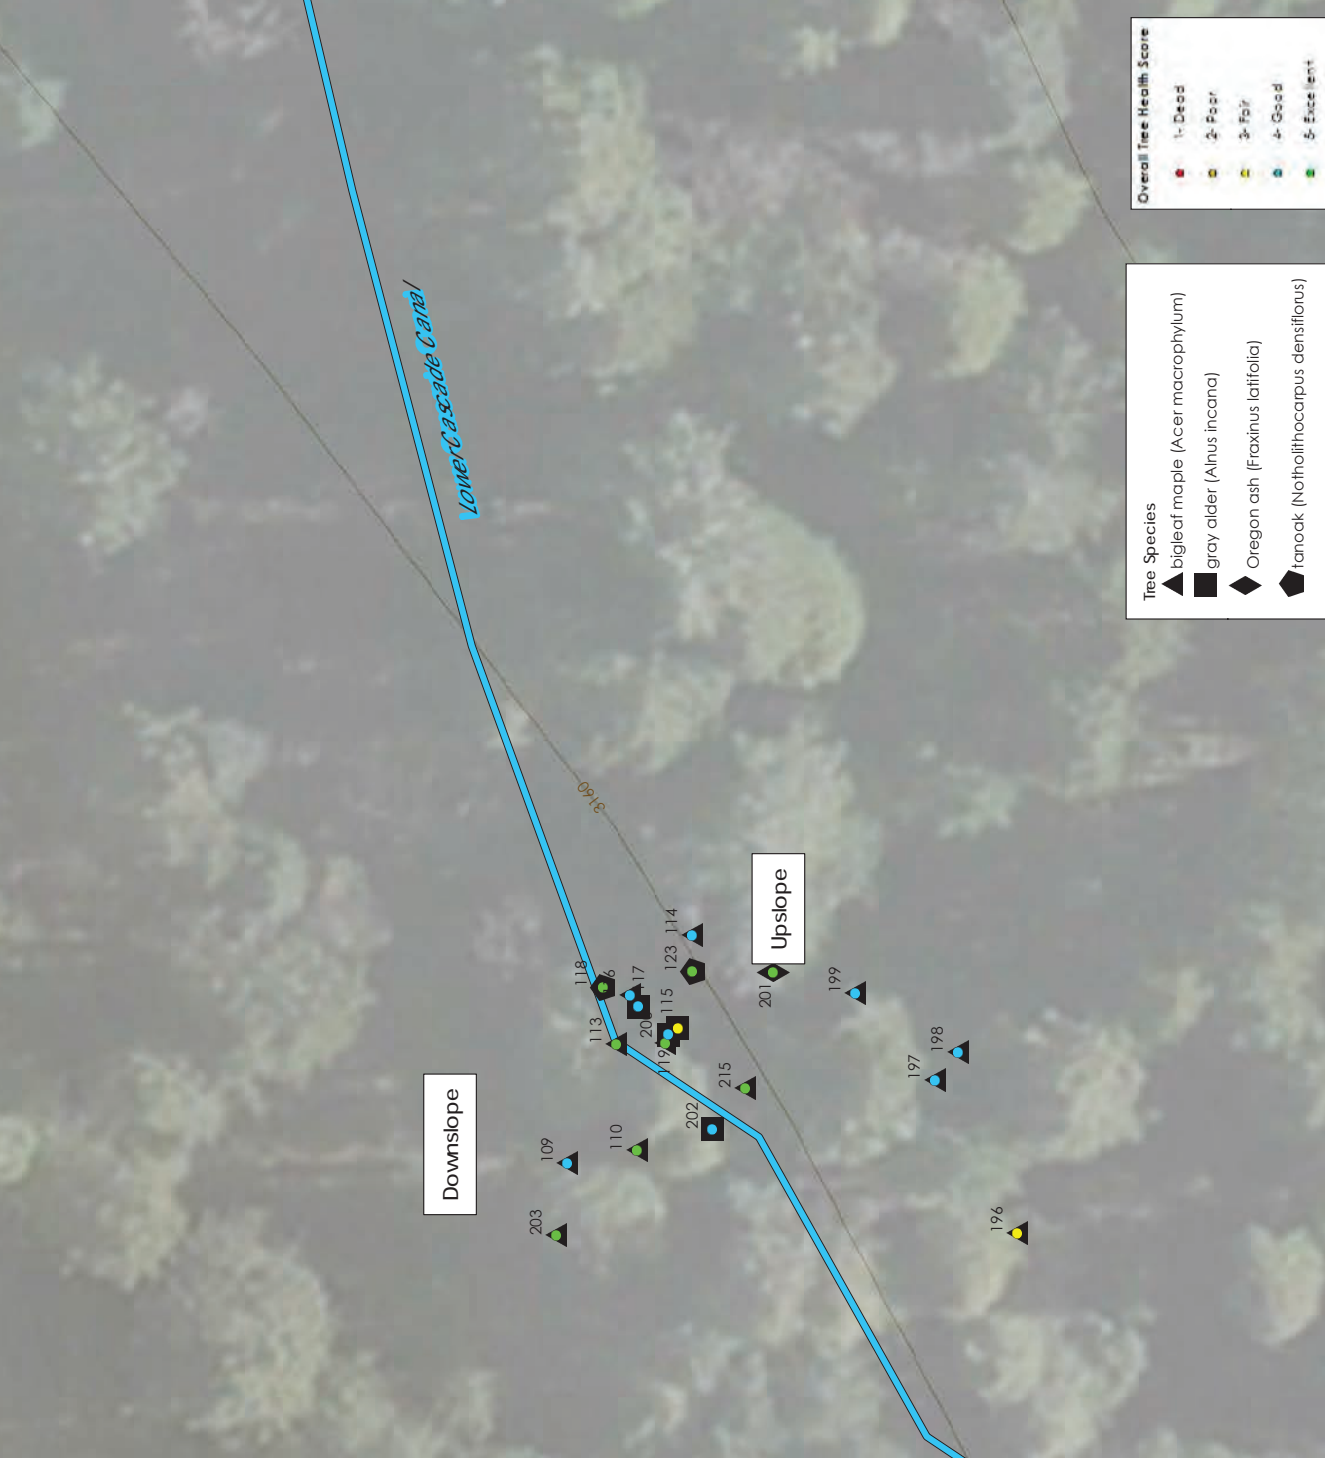
Appendix A. 2.3
 LCC Site 3- Tree Health Assessment Results Map
 Long Term Canopy Cover Study and Pond Study, Monitoring Year 4
 Nevada Irrigation District, Banner Cascade Project

During Year 4 monitoring, 20 riparian trees were surveyed at Site 3 on the LCC. Tree species surveyed include bigleaf maple, gray alder, and Pacific dogwood. Bigleaf maple is the dominant riparian tree species. Various upland tree species are also present at Site 3, including Douglas-fir and incense cedar; however, they were not surveyed due to their upland status. The DBH for the surveyed trees ranged from 1.1 to 12.3 inches. Overall health of trees at Site 3 is fair. Trees surveyed exhibit some foliage discoloration, insect damage to the leaves and tree bark, and potential disease presence. Surface growth is present on trunks and/or foliage, specifically biological growths such as moss and lichen. Bark health for the trees surveyed is fair, as some trees exhibit decay, and or general bark abnormalities. Disease was observed on surveyed trees, and insect infestations were abundant (i.e., observed on all surveyed trees). No parasitic presence was observed. General site conditions yield excessive encroachment by non-native and invasive understory species and vining up the tree trunks (e.g., English ivy [*Hedera helix*]).

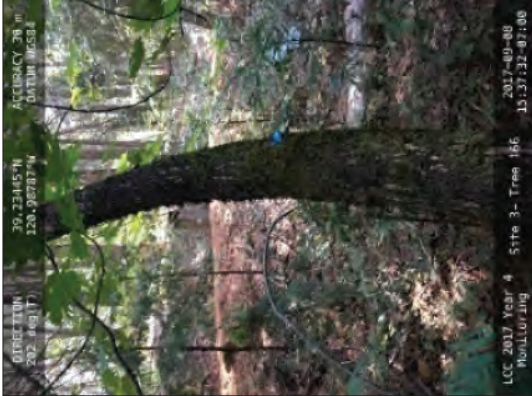
<p>LCC 2017 Year 4 Monitoring Site 3 - Tree 186 2017-09-08 15:37:32-07:00</p> <p>DIRECTION 302 degrees 39.234857N 120.987917W ACCURACY 2.0 m DATUM WGS84</p>
<p>LCC Site 2 (Year 0, 2013). Southwest aspect</p>	<p>LCC Site 3 (Year 2, 2015). West facing aspect</p>	<p>LCC Site 3 (Year 4, 2017). Downslope location</p>

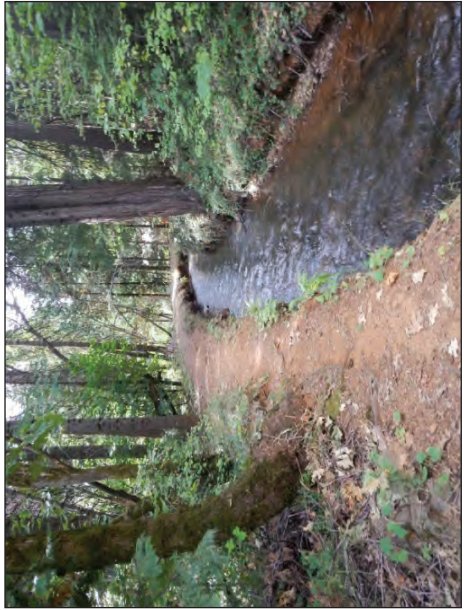
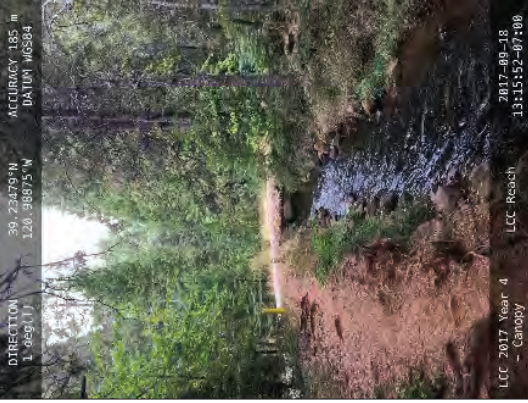
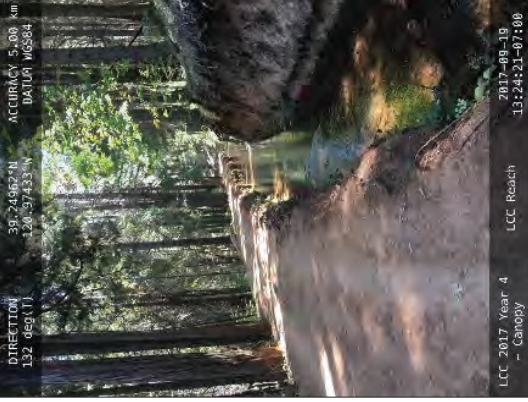
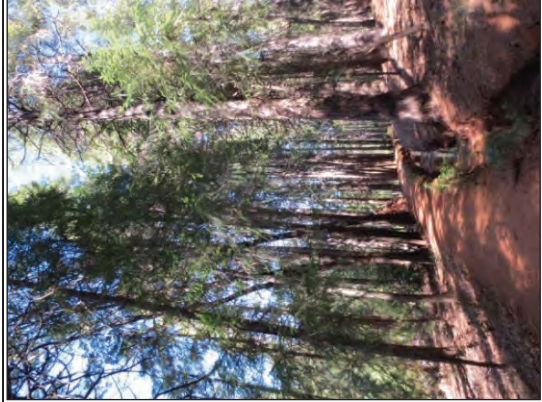
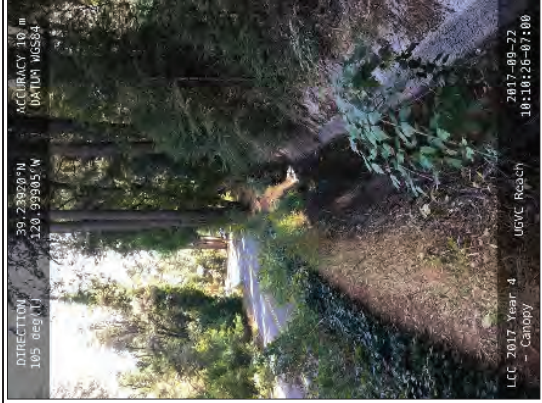
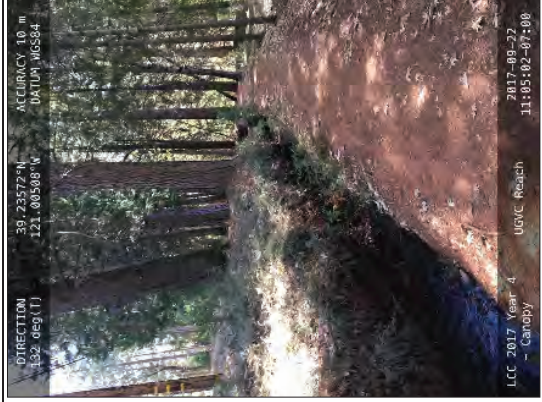
Canopy Cover Study: Canopy Cover Assessment (Baseline Year 0, 2013; and Monitoring Year 4, 2017)

<p>DIRECTION 132 deg(T)</p> <p>39.23572°N 121.00508°W</p> <p>ACCURACY 10 m DATUM NAD83</p> <p>LCC 2017 Year 4 - Canopy</p> <p>2017-09-27 11:05:02-07:00</p> <p>UGVC Reach</p>
<p>LCC Reach (Year 0, 2013). Southeast facing aspect</p>	<p>LCC Reach (Year 4, 2017)</p>	<p>LCC Reach (Year 4, 2017)</p>
<p>UGVC Reach (Year 0, 2013). Northwest facing aspect</p>	<p>UGVC Reach (Year 4, 2017)</p>	<p>UGVC Reach (Year 4, 2017)</p>

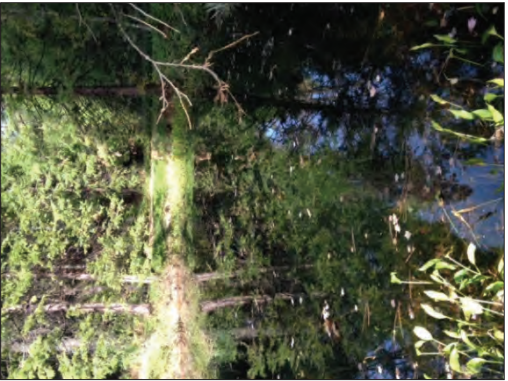
<p>LCC Pond 1 (Year 4, 2017). Sedimentation at upstream source</p>  	<p>LCC Pond 1 (Year 4, 2017). Water source upstream</p>  
<p>LCC Pond 2 (Year 0, 2013). Located off upper Spring Road. North facing aspect</p>	<p>LCC Pond 2 (Year 4, 2017)</p>	<p>LCC Pond 2 (Year 4, 2017). Culvert outlet to upland located to the left</p>

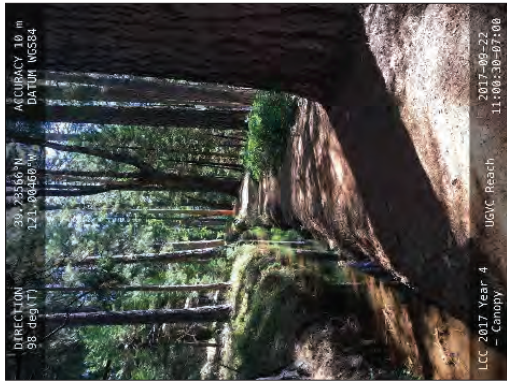
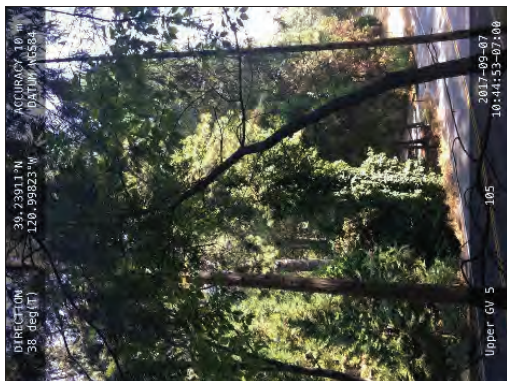
<p>DIRECTION 58 deg(T) 39.23811°N 120.99823°W ACCURACY: 10 m DATUM: NGS84 Upper GV 5 105 2017-09-07 10:44:53-07:08 Site 5</p>	<p>UGVC Site 5. Downslope; adjacent to roadside</p>   <p>DIRECTION 96 deg(T) 39.24357°N 121.00850°W ACCURACY: 5 m DATUM: NGS84 LCC 2017 Year 4 Monitoring Site 5 2017-09-15 11:20:53-07:00 DS Canal Site 6 (control-site). Downslope; moderate understory with dense litter covering ground</p>	<p>UGVC Site 5. Upslope; denser trees and understory on upslope (i.e., non-roadside location)</p>

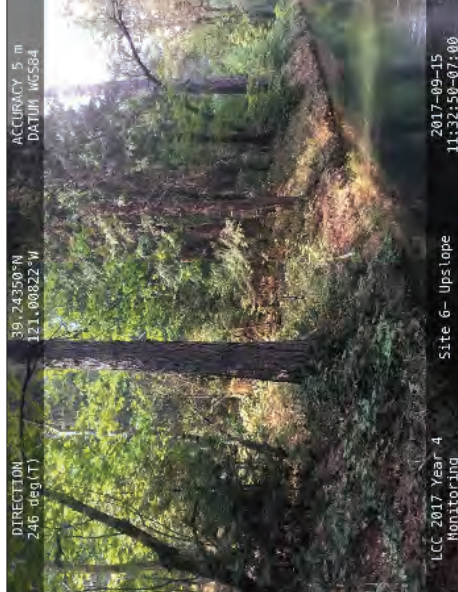
<p>DIRECTION 246 deg(T) 39.24350°N 121.00822°W ACCURACY: 5 m DATUM: NGS84 LCC 2017 Year 4 Monitoring Site 6- Upslope 2017-09-15 11:32:50-07:00 DS Canal Site 6 (control-site). Upslope; dense understory of conifer saplings and poison oak (<i>Toxicodendron diversilobum</i>)</p>	<p>UGVC Site 5. Downslope, example of study tree (#105), roadside location</p>   <p>DIRECTION 202 deg(T) 39.24225°N 121.00833°W ACCURACY: 10 m DATUM: NGS84 LCC 2017 Year 4 Monitoring Site 6- Tree 05 2017-09-15 09:13:40-02:00 DS Canal Site 6 (control-site). Example study tree (#95), competition with adjacent trees for resources</p>
