**Lower Cascade Canal and
Upper Grass Valley Canal Long
Term Canopy Cover Study, Tree
Health Assessment Report -
Monitoring Year 2**

Banner Cascade Pipeline Project

Prepared for:
Nevada Irrigation District
1036 West Main Street
Grass Valley, CA 95945

March 3, 2016

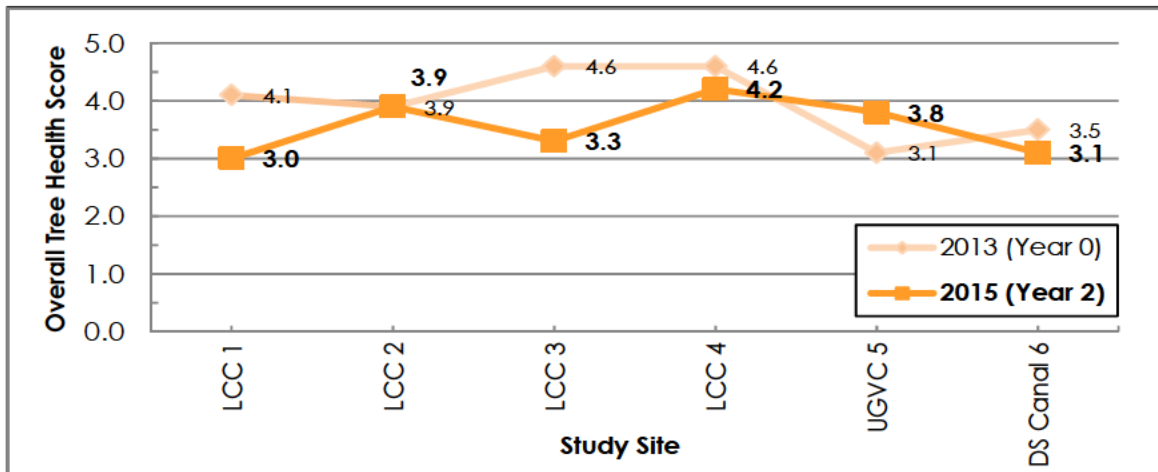
Figure 4.7 Tree Health Assessment Scores for Average Overall Tree Health by Study Site

Tree Health: 1- Dead: 2- Poor: 3- Fair: 4- Good: 5- Excellent

General environmental conditions and overall riparian forest health relative to the Sierra Nevada foothill region and the associated Project is further discussed in Section 5.0. Other prevailing site-specific conclusions include the notable sweeping decrease in new growth presence (i.e., average 50 percent decrease) at all of the study sites between Monitoring Year 0 and Year 2. Regeneration of riparian forest is greatly dependent on hydrology, both groundwater/seepage and overall precipitation, thus supporting forest composition and maintenance. Between Monitoring Year 0 and Year 2, the region experienced drought conditions (i.e., the overall decrease in annual precipitation), as well as a spike in overall seasonal temperature. Decreased water availability and the offset of normal seasonal variation subsequently can drive increases in non-native and upland species encroachment and growth within riparian forest communities. These conditions can also inflate broad scale tree disease as well as insect infestation. It can be concluded that the aforementioned factors compounded with a decrease in overall canal flows leads to the overall observed lower tree health conclusions for the Project study sites.

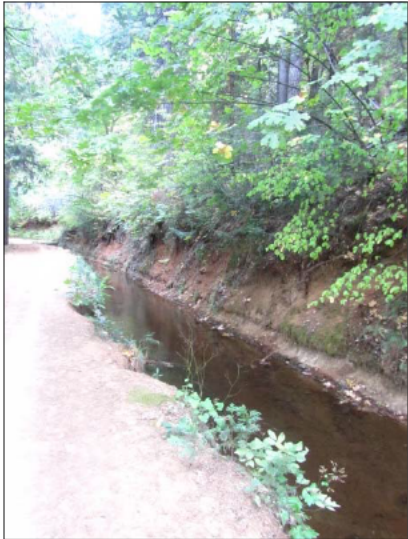
Photos 1-4: Site 1 Lower Cascade Canal	
<p>1</p>

<p>LCC Site 1, on the east (downslope) side of the canal, facing upstream. Northeast aspect.</p>	<p>LCC Site 1, on the east (downslope) side of the canal, facing downstream. Southwest aspect.</p>
<p>3</p>

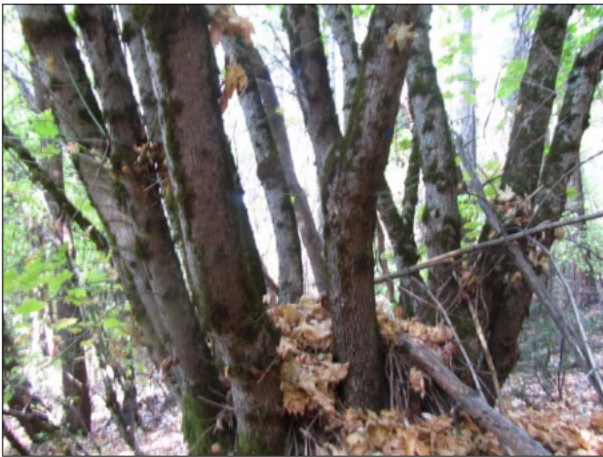
<p>An example of a multi-stem Pacific dogwood tree at LCC Site 1 (tag number 206, 17 stems total).</p>	<p>An example of tree root disease/wood decay leading to down woody debris at LCC Site 1.</p>

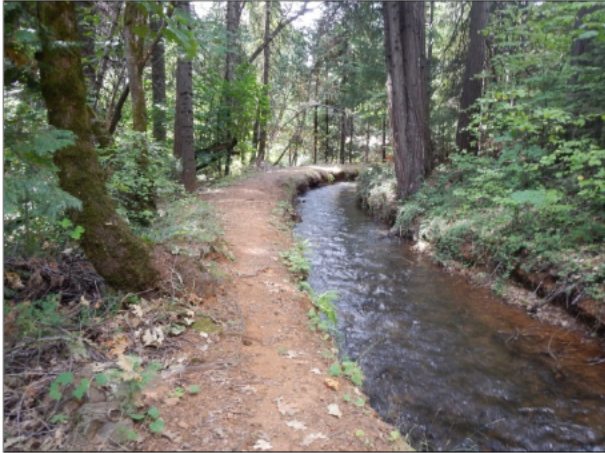
Photos 5-10: Site 2 Lower Cascade Canal	
<p>5</p>

<p>LCC Site 2, on the west (downslope) side of the canal, facing upstream. Northwest aspect.</p>	<p>LCC Site 2, on the west (downslope) side of the canal, facing downstream. Southeast aspect.</p>
<p>7</p>

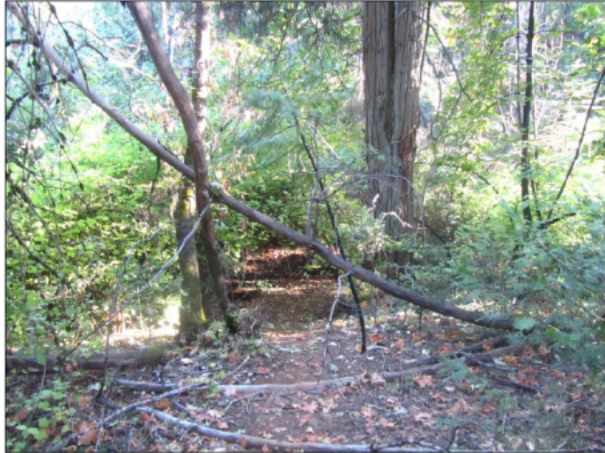
<p>Foot path/trail going through the middle of LCC Site 2 on the west (downslope) side of the canal. West aspect.</p>	<p>East (upslope) side of LCC Site 2. West aspect.</p>

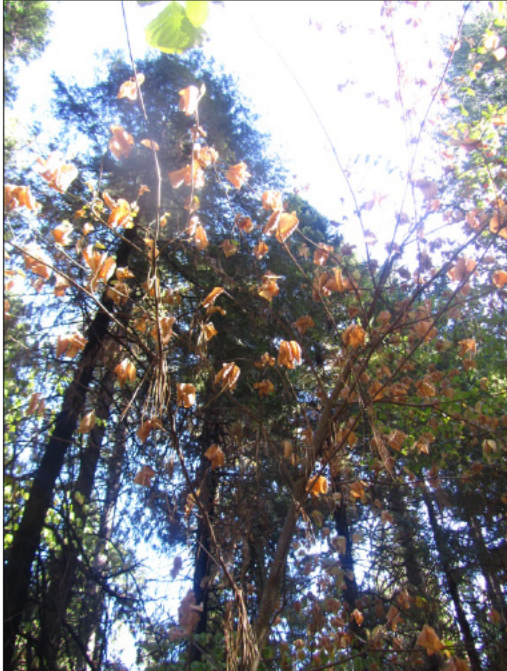
<p>9</p>

<p>An example of a drought-stressed Pacific dogwood tree canopy on the east (upslope) side of LCC Site 2.</p>	<p>An example of biological (composite algae) growth on Pacific dogwood tree bark at LCC Site 2.</p>
<p>Photos 11-14: Site 3 Lower Cascade Canal</p>	
<p>11</p>

Early defoliation, or leaf browning, due to drought stress was observed at the Project study sites due to low regional rainfall between Monitoring Year 0 and Year 2. Riparian tree drought stress is observable when leaves of mature trees turn brown and prematurely begin to drop well in advance of the normal time for leaf fall (Swiecki et al. 2006). At the study sites, drought-induced defoliation was differentiated from branch die-back by the fact that buds and twigs of drought-defoliated branches remained alive. It should be noted that for droughts lasting multiple years, symptoms of drought-induced defoliation can be widespread, particularly in riparian communities. It is recommended that drought-stress assessments continue to be considered in subsequent Project monitoring years. Decreased hydrology (i.e., canal flows) at the study sites can be concluded as not a primary indicator in the decreases in overall tree health averages in light of recent drought in the region. Total precipitation for Monitoring Year 0 and Year 2 are outlined by month for Nevada City, California in Table 5.0 below.

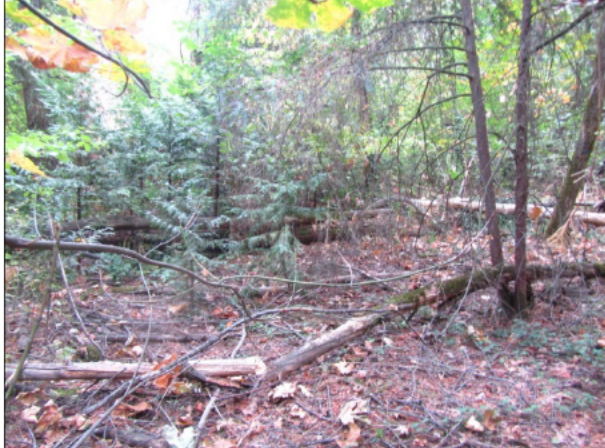
<p>13</p>

<p>Down woody debris on the downslope side of LCC Site 3. West aspect.</p>	<p>View of the upslope side of LCC Site 3 from the downslope (west) side of the canal. East aspect.</p>
<p>Photos 15-20: Site 4 Lower Cascade Canal</p>	
<p>15</p>

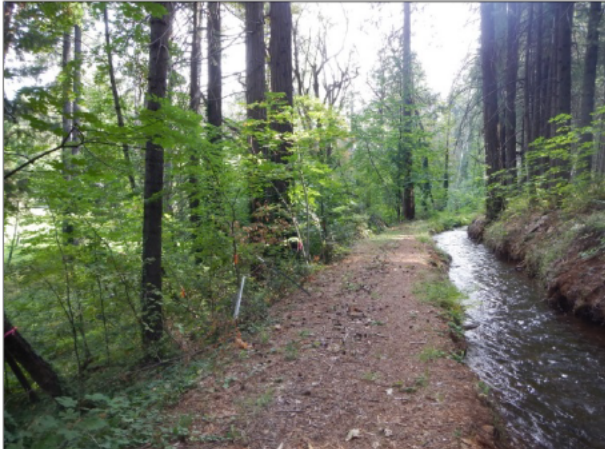
<p>LCC Site 4, on the west (downslope) side of the canal, facing upstream. Northeast aspect.</p>	<p>LCC Site 4, on the west (downslope) side of the canal, facing downstream. Southwest aspect.</p>

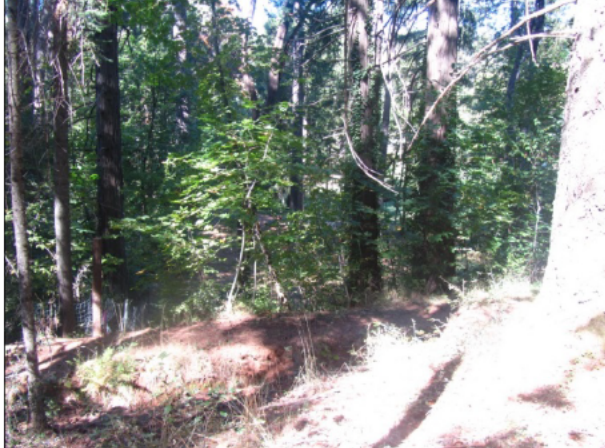
<p>17</p>

<p>Downslope (west) side of the canal at LCC Site 4. Note the property owner installed a fence on the left side of the photo. Northwest aspect.</p>	<p>The upslope (east) side of the canal at LCC Site 4. Southeast aspect.</p>
<p>19</p>

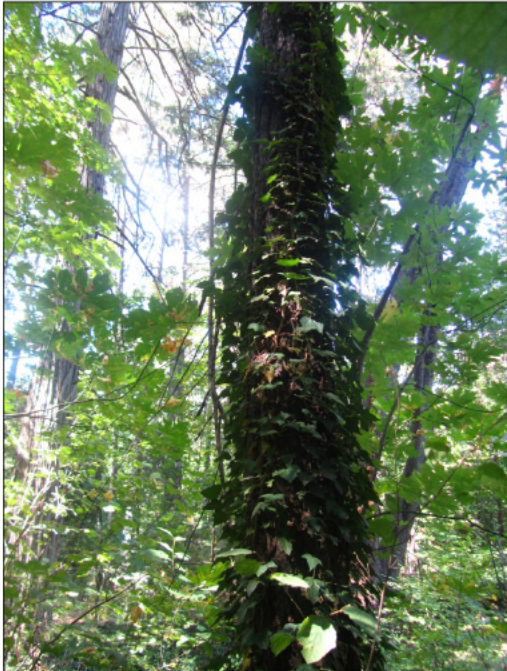
<p>An example of biological (English ivy) growth/encroachment by non-native/invasive species on tree bark at LCC Site 4.</p>	<p>An example of fungal growth (tar spotting; black circular spot patterns) on bigleaf maple foliage. This foliage also exhibits another fungal disease, powdery mildew.</p>

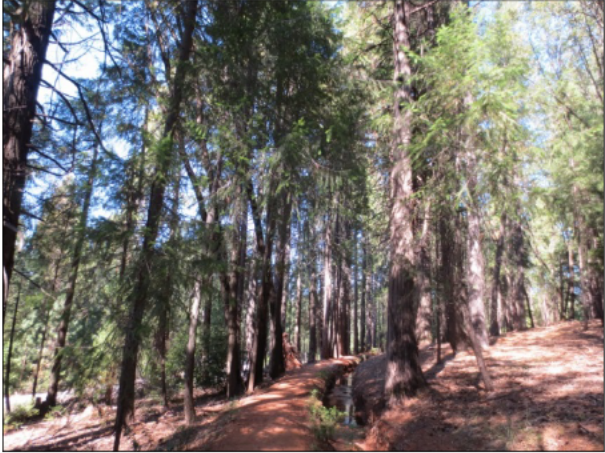
Photos 21-22: Site 5 Upper Grass Valley Canal	
21	22

UGVC Site 5, on the south (downslope) side of the canal, facing upstream. East aspect.	UGVC Site 5, on the south (downslope) side of the canal, facing downstream. West aspect.
Photos 23-26: Site 6 DS Canal (Control Site)	
23	24

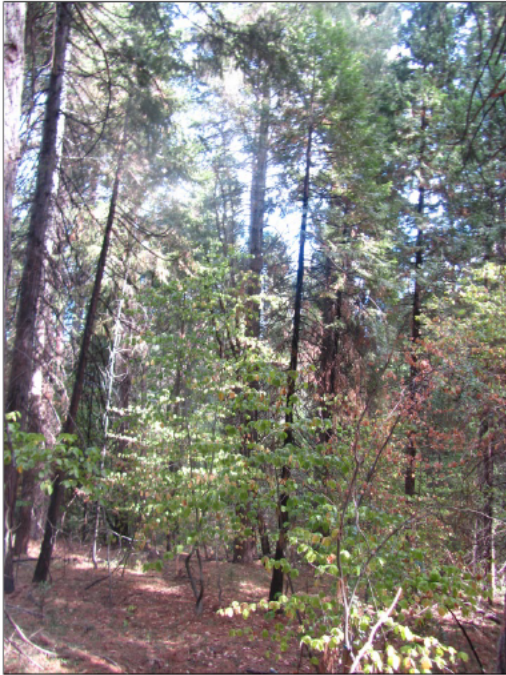
25

DS Canal (Control Site) Site 6, on the south (downslope) side of the canal. South aspect.

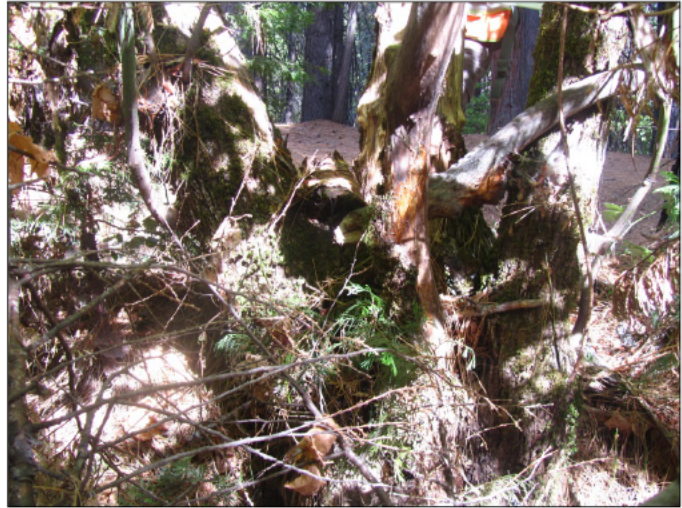
26

DS Canal (Control) Site 6, on the north (upslope) side of the canal. South aspect. An example of wood decay/ root rot.
