SUBJECT: Lower Cascade Canal and Upper Grass Valley Canal Tree Health, Canopy Cover and Pond Monitoring Report – Year 8 (Project # 6593-2)

**Banner Cascade Pipeline Project
Tree Health, Canopy Cover, and
Pond Monitoring Report – Year 8**

Tree Health, Canopy Cover, and Pond
Monitoring Report – Year 8

Lower Cascade, Upper Grass Valley,
and DS Canals

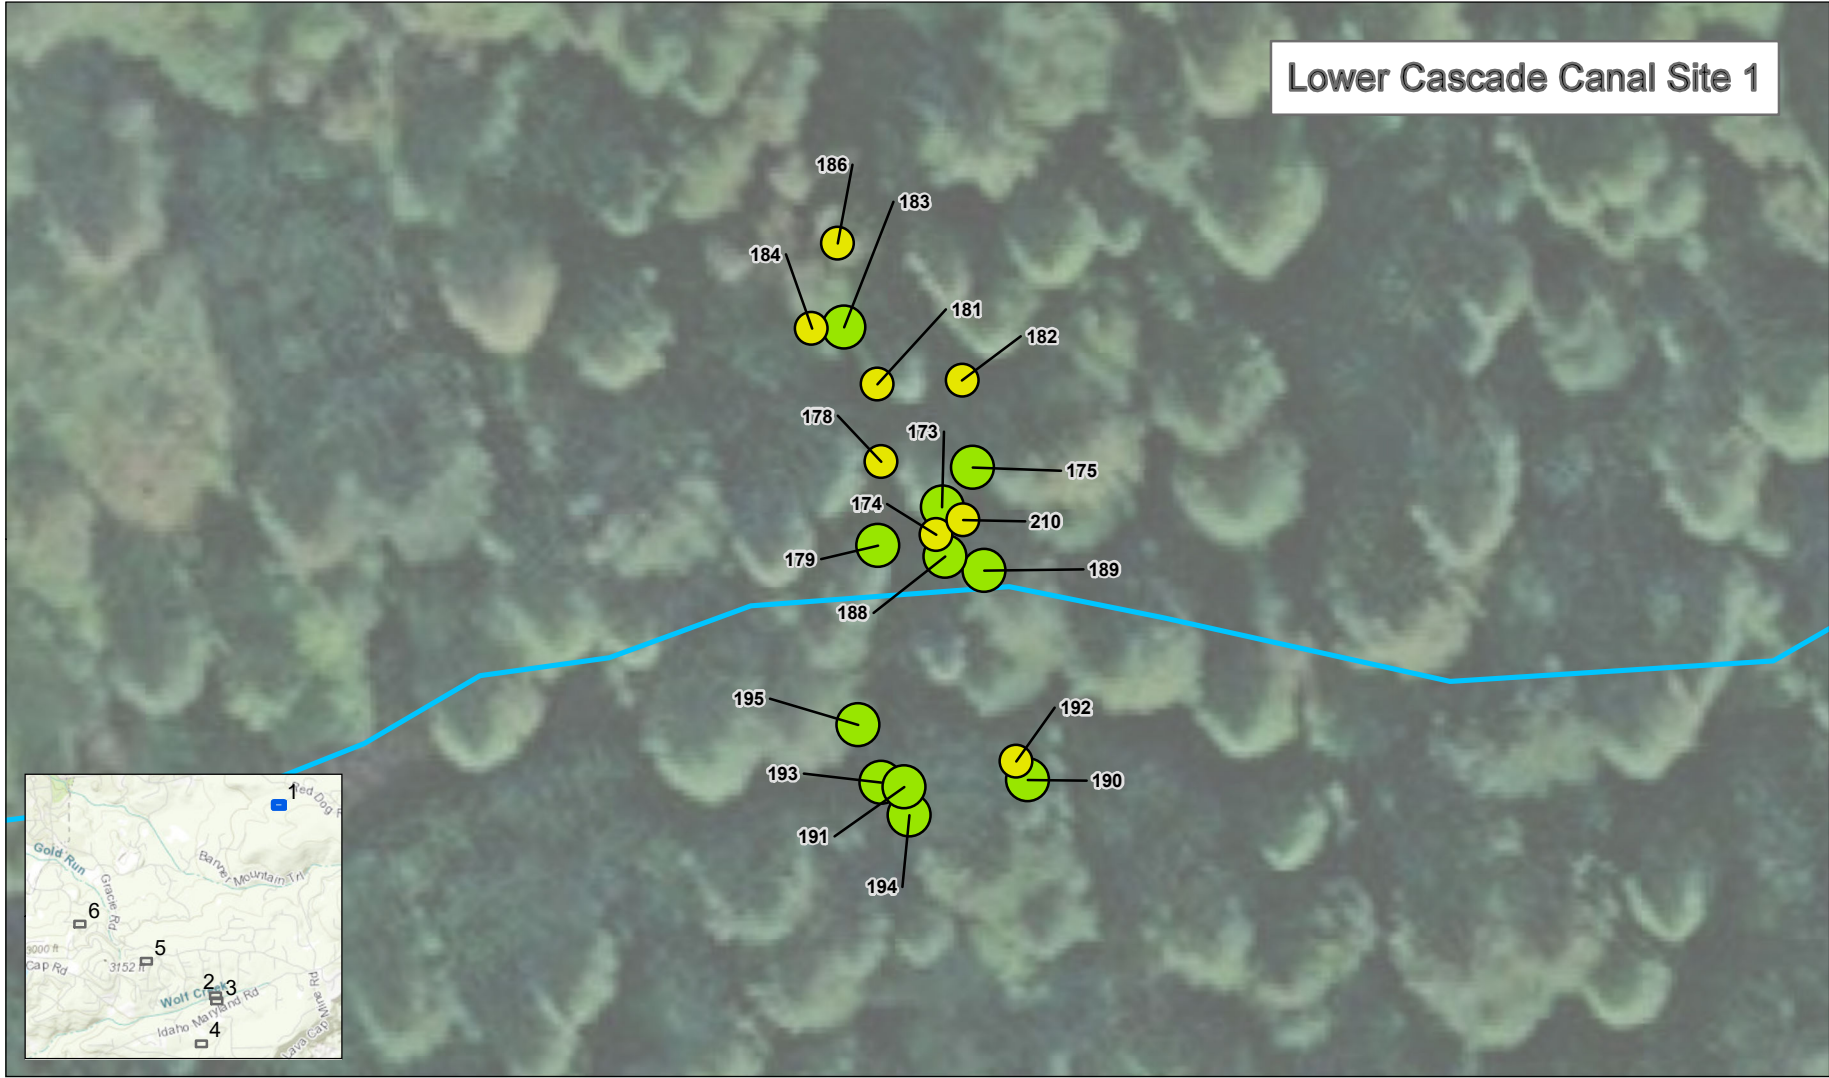
Lower Cascade Canal Site 1

In Monitoring Year 8, 19 riparian trees were surveyed at Site 1 on LCC on September 20, 2019, including bigleaf maple, Pacific dogwood, and gray alder. Three new dead trees were found. Most trees surveyed had full to partial canopy cover and good bark health, and exhibited DBH growth, new growth, surface growths, foliage discoloration, and insect damage. Disease was minimal at this site, but a few tree trunks were encroached by parasites such as honeysuckle and poison oak. Overall tree health at Site 1 is good, with a range of health scores from 8 to 14 and an average health score of 10 (Table 4-1, Graph 4-1).

General site conditions included down woody debris in the understory on both up and downslope portions of Site 1. Various upland tree species are also present at Site 1, including Douglas-fir, beaked hazelnut, incense cedar, and Pacific madrone (Appendix F).

Since Baseline Year 0, trees at Site 1 improved from partial to medium canopy cover, and bark health remained good. However, presence of abnormal leaf color and insects increased from barely present at Site 1 to present in most trees. Presence of new growth greatly decreased from Baseline Year 0 to Monitoring Year 4 but made a substantial recovery in Monitoring Year 6 and sustained that into Monitoring Year 8. Surface growth remained highly prevalent and diseases and parasites remained minimal across monitoring years, though honeysuckle and other parasitic plants were observed in increasing quantity at Site 1. Two tree deaths were observed at Site 1 between Baseline Year 0 and 6, and three new trees were confirmed dead in Monitoring Year 8. In comparison with Monitoring Year 6, trees surveyed in Monitoring Year 8 exhibited overall improvements in DBH and new growth, as well as less disease. Overall tree health at Site 1 remains good since Baseline Year 0, oscillating on health between Monitoring Years 2 through 8 (Table 4-1, Graph 4-1). Although three new trees were found dead, the other surviving trees are showing better health at this site as compared to the previous two monitoring years. The three trees that died were previously in the “fair health” category and had been declining over the years.

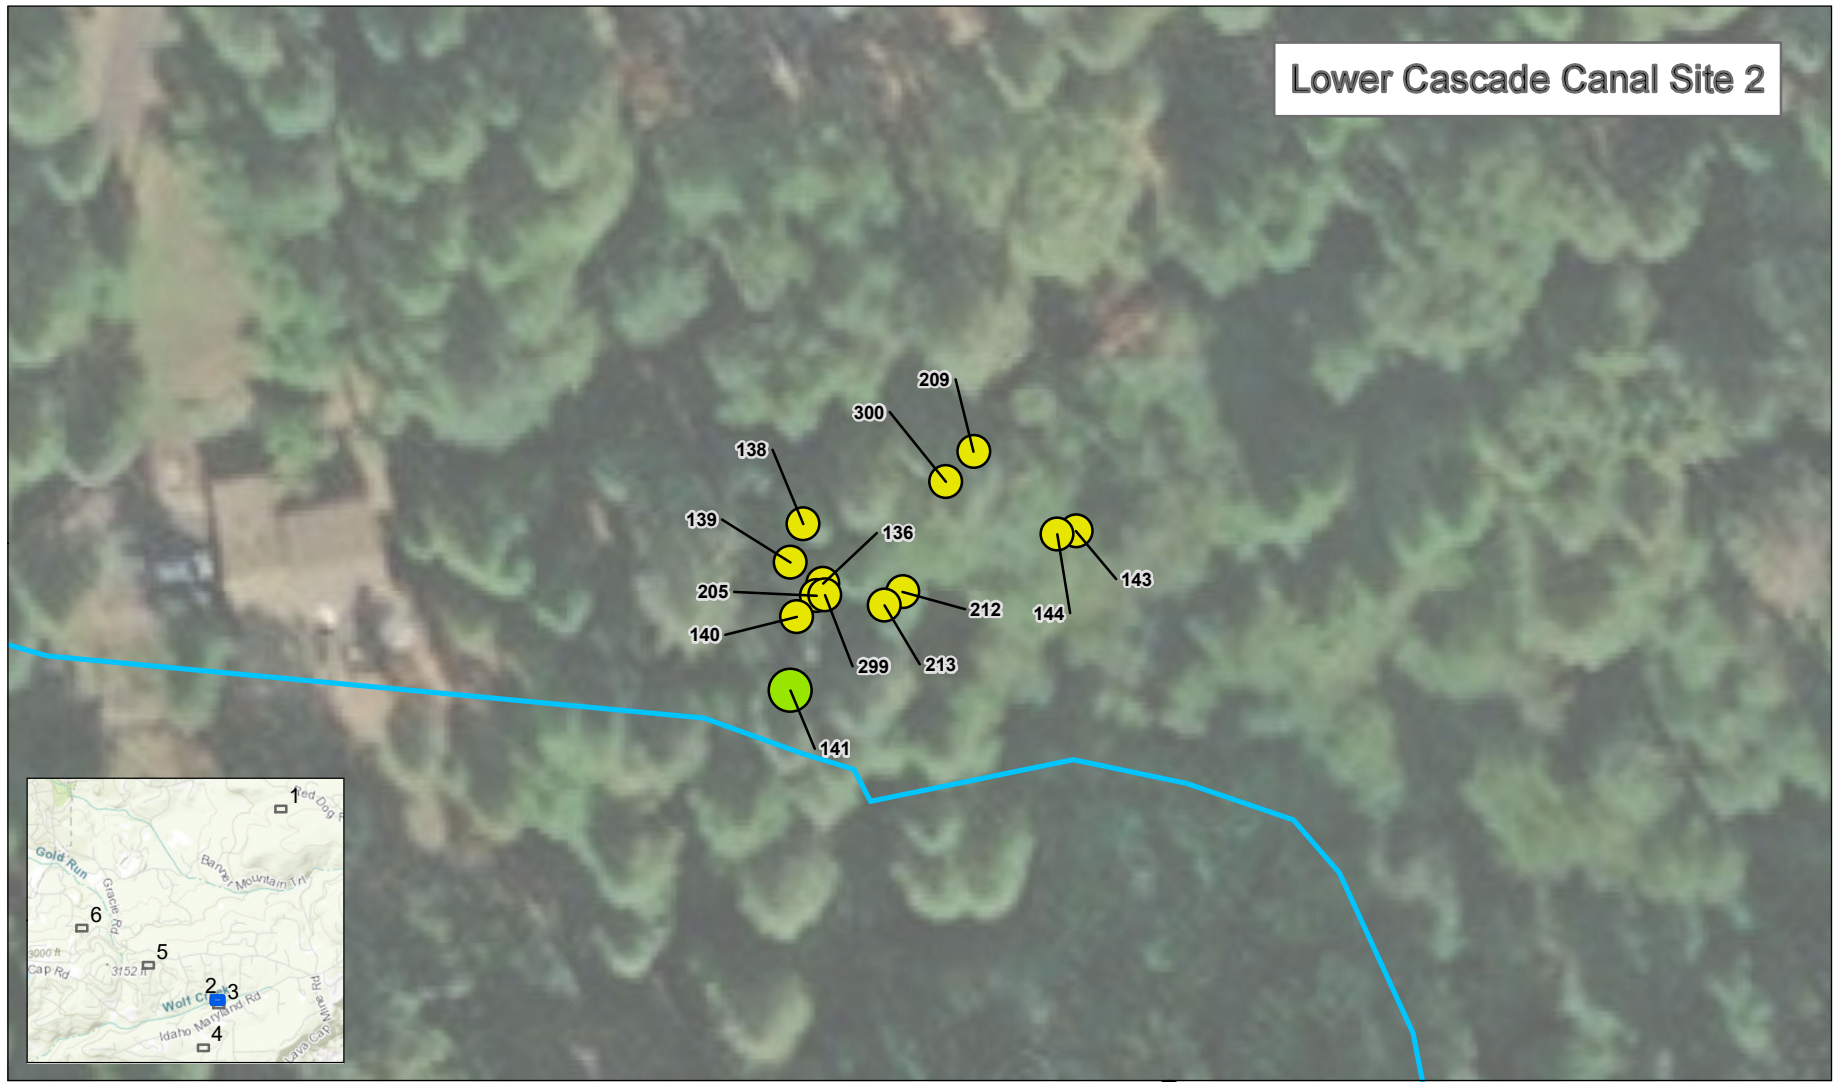
Lower Cascade Canal Site 2

During Year 8 monitoring, 13 riparian trees were surveyed at Site 2 on LCC on September 15, 2021. Tree species surveyed include bigleaf maple, gray alder, and Pacific dogwood. No new trees were found dead. Most trees surveyed had full to partial canopy cover and good bark health, and exhibited new growth, surface growths, and insect damage and infestation. Disease was minimal at this site, but approximately half the trees surveyed exhibited foliage discoloration and parasites such as honeysuckle and Himalayan blackberry (*Rubus armeniacus*) on trunks and branches. Overall tree health at Site 2 is good, with a range of health scores from 8 to 13 and an average health score of 10 (Table 4-2, Graph 4-2).

General site conditions included excessive encroachment by non-native understory species (e.g., Himalayan blackberry), as noted in previous years. Mechanical removal of upslope study trees in 2018 and installation of fencing by private landowners rendered the upslope portion of the site unable to be surveyed. As such the upslope trees are no longer a part of the study. Drainage fed by LCC and rainfall/runoff was observed near trees surveyed downslope of LCC; it did not have water at the time of the survey this year. Various upland tree species are also present at Site 2, including black oak, beaked hazelnut, and incense cedar.

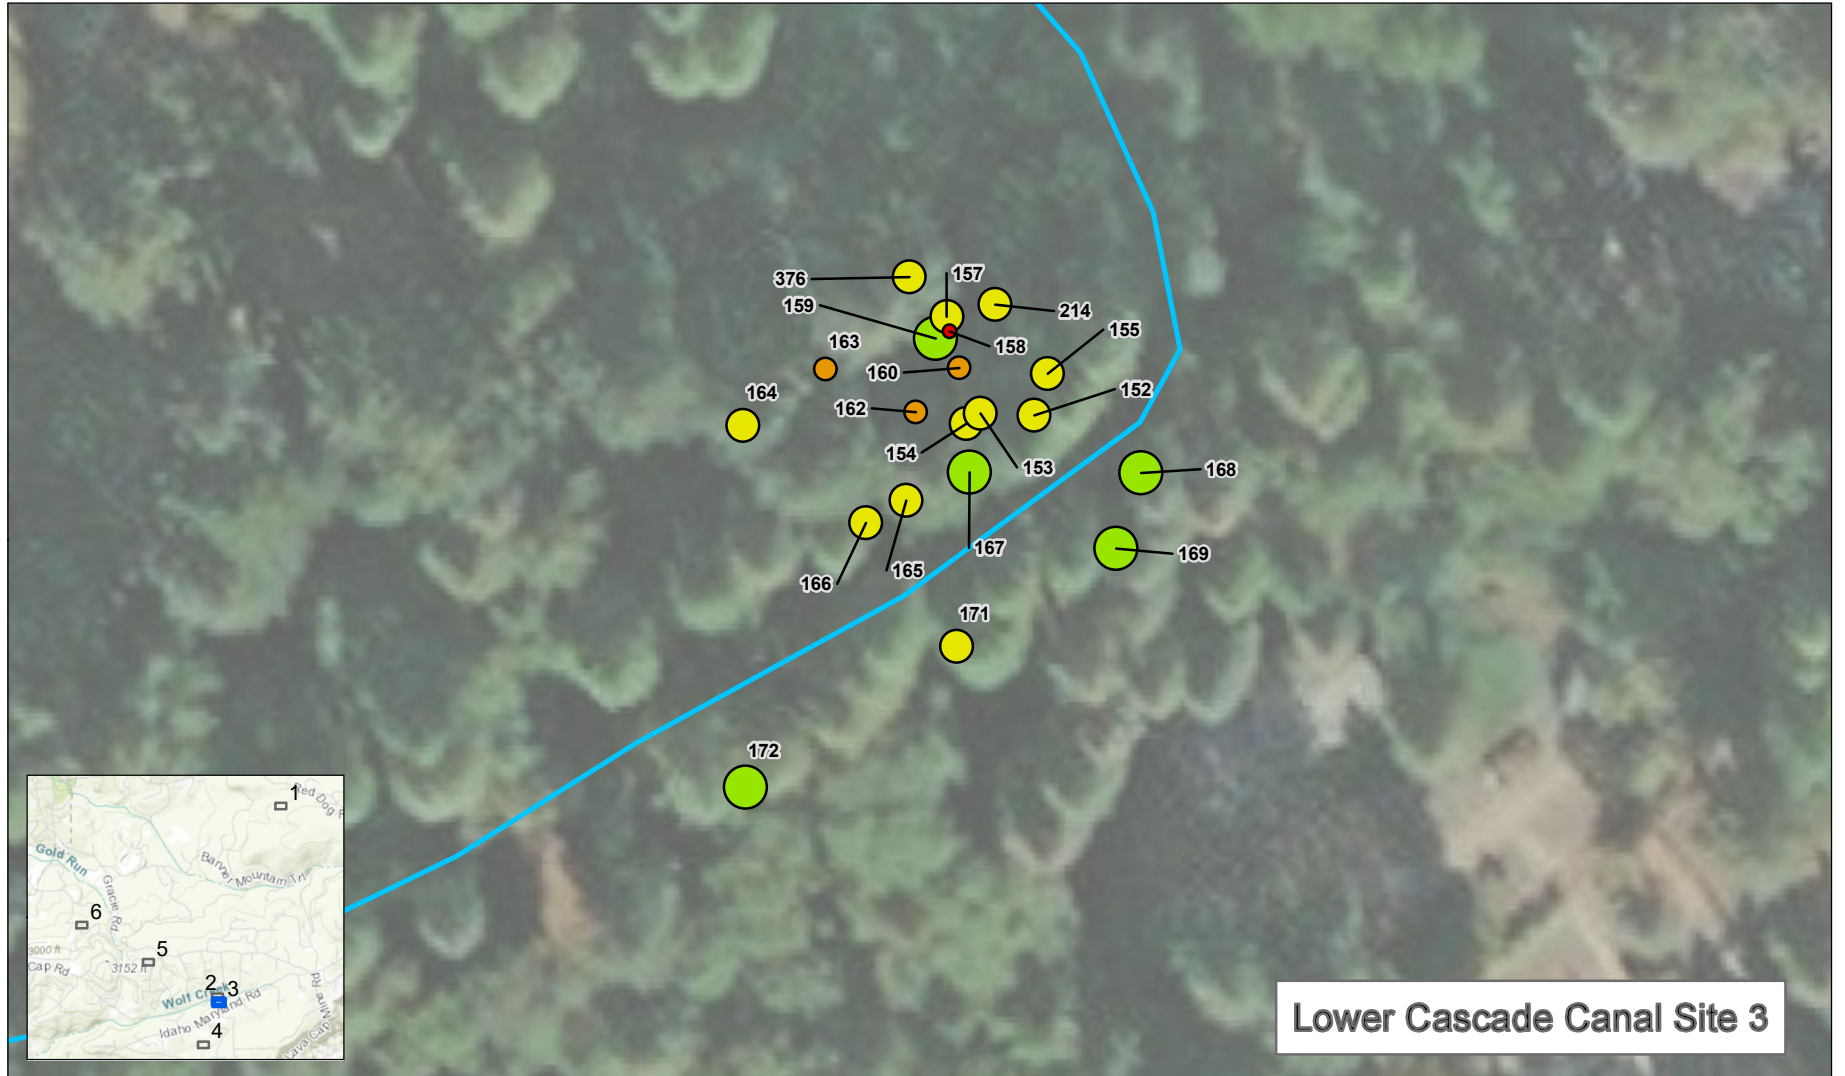
Lower Cascade Canal Site 3

General site conditions included encroachment by non-native and invasive understory species that also were vining up the tree trunks (e.g., English ivy). Various upland tree species are also present at Site 3, including Douglas-fir and incense cedar.

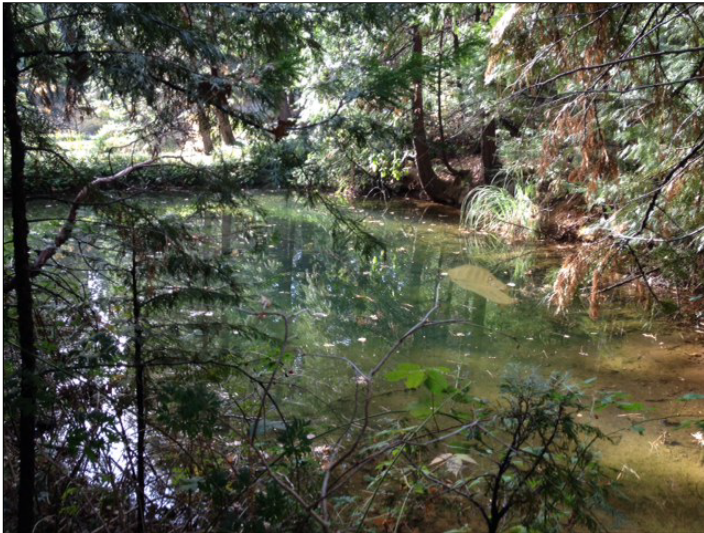
Photograph 43: 2013. LCC Pond 1. Southwest facing aspect.

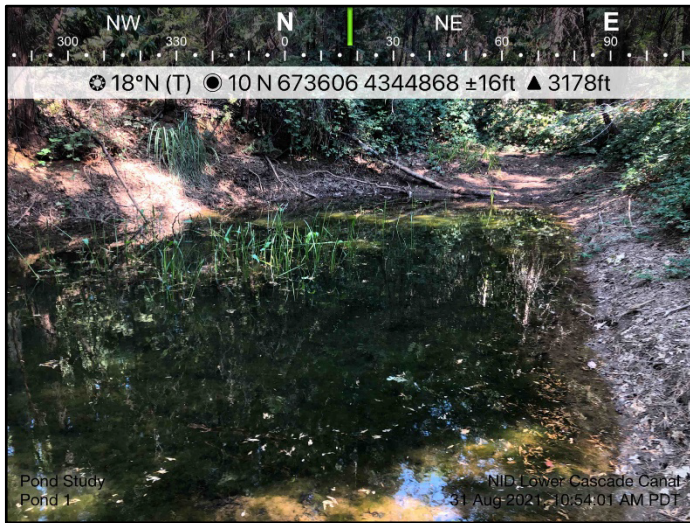
Pond 1 is adjacent to but physically separated from Pond 2 by a dirt access road. However, the two ponds are connected via an approximate 6-inch culvert, which allows water to flow from Pond 1 to Pond 2 when water levels allow. At the time of the 2021 assessment, water levels were much too low to be hydrologically connected (Photographs 45–48).

Photograph 45: 2021: LCC Pond 1. North facing aspect.

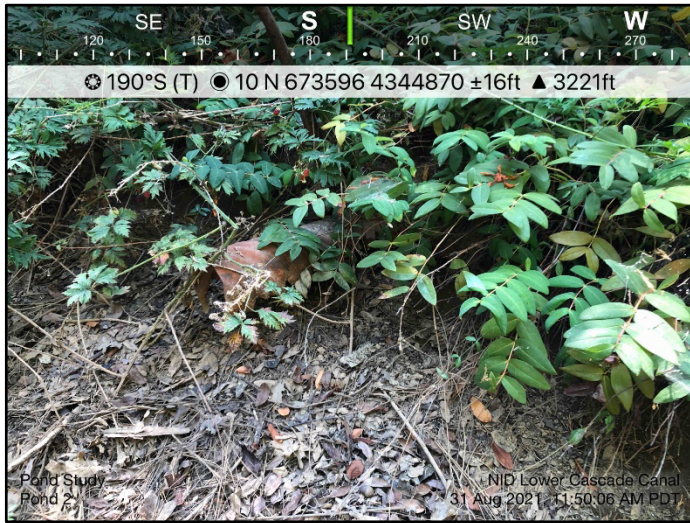
Photograph 47: 2021: Culvert between LCC Pond 1 and Pond 2. Photo taken from the Pond 1 side located in the southern corner of Pond 1.

-
- little woody debris within pond
 - tree frog larvae observed in pond
 - water beetles.
 - culvert connecting two ponds ~~as follows~~ couple feet above current water depth.

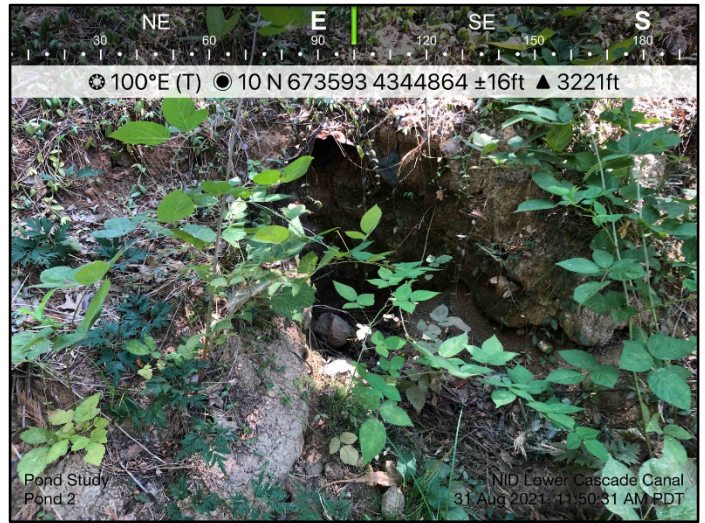
Photograph 48: 2021: Culvert between LCC Pond 1 and Pond 2. Photo taken from the Pond 2 side located in the northern corner of Pond 2.

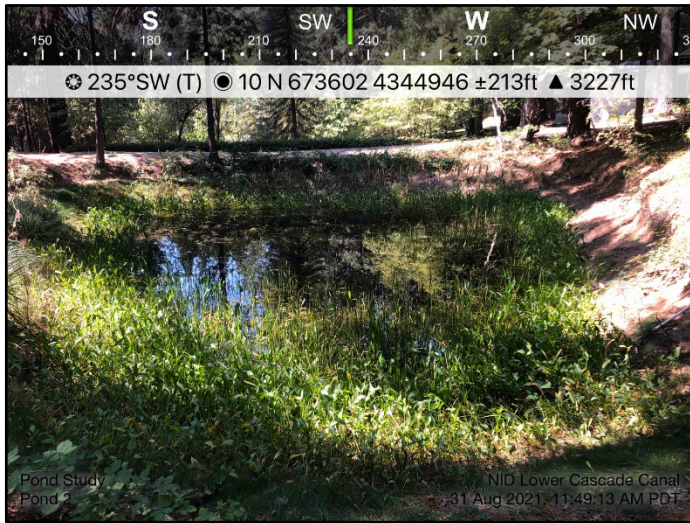
Pond 2 is located at latitude 39.235182 and longitude -120.989522 (WGS-84) and adjacent to the LCC. As described above, Pond 2 is situated within an upland forest habitat and includes the same dominant overstory and understory vegetative species. Pond 2 is also a perennial wetland, with little to no overhanging vegetation; but approximately 50% of its surface is comprised of emergent vegetative species including narrowleaf plantain (*Alisma lanceolatum*) and narrowleaf cattail (*Typha angustifolia*) (Appendix D, Photographs 49–50). Pond 2 is located adjacent to and downslope of Pond 1 and is surrounded by dirt access roads on all sides. As mentioned above, Pond 1 is supplied with purchased water from April 15 through October 15 from the LCC, and feeds Pond 2 via a culvert approximately 6 inches diameter when water levels allow (Appendix D, Photographs 47–48). Potential seepage from the NID canal located upslope and to the northeast may also supply Pond 2 with water.

Photograph 49: 2021: LCC Pond 2. Southwest facing aspect.

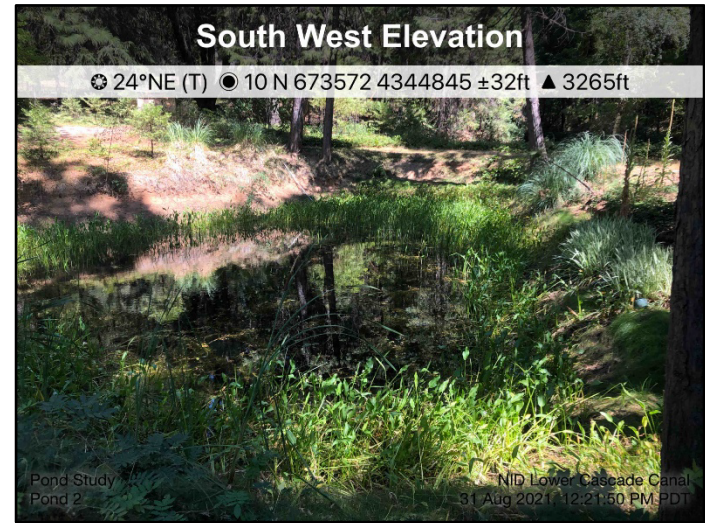
Photograph 50: 2021. LCC Pond 2. Northeast facing aspect looking towards Pond 1.

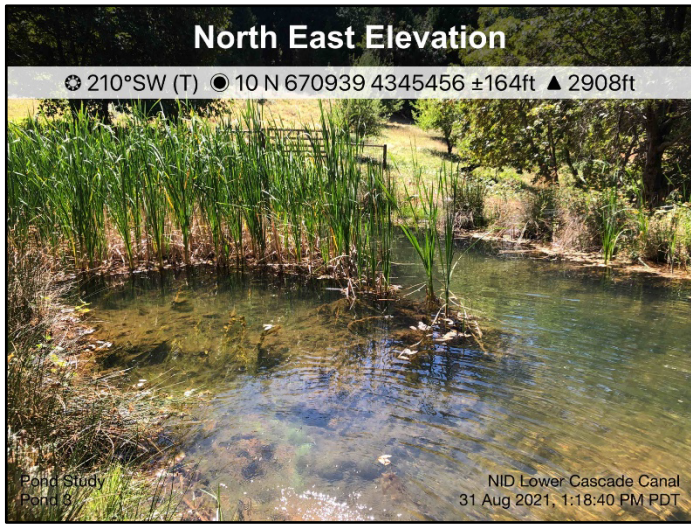
Pond 3, the reference site for the Pond Study, is located at latitude 39.24093 and longitude -121.02055 (WGS-84) and adjacent to a piped section of the DS Canal. Pond 3 is in upland forest habitat including incense cedar and ponderosa pine (*Pinus ponderosa*). No overhanging vegetation is present; however, emergent species including common cattail (*Typha latifolia*) is choking out much of the pond's surface area (Appendix D, Photographs 53–54). There is a water service agreement on the parcel where Pond 3 is located that purchases water through the irrigation season (i.e., April 15 through October 15) from DS Canal. No water is purchased through the winter months; however, the water service could potentially leak water due to residual canal flows and increased annual precipitation. The water purchased from the DS Canal feeds through a culvert and/or overflows directly into Pond 3, which is otherwise confined by the surrounding topography. There is also an additional culvert that drains from Pond 3 to an additional pond below (Appendix D, Photographs 53–54). For a list of observed wildlife species at Pond 3, please refer to Appendix F of this report.

Photograph 53: 2021: DS Canal Pond 3 (reference site). Southwest facing aspect.

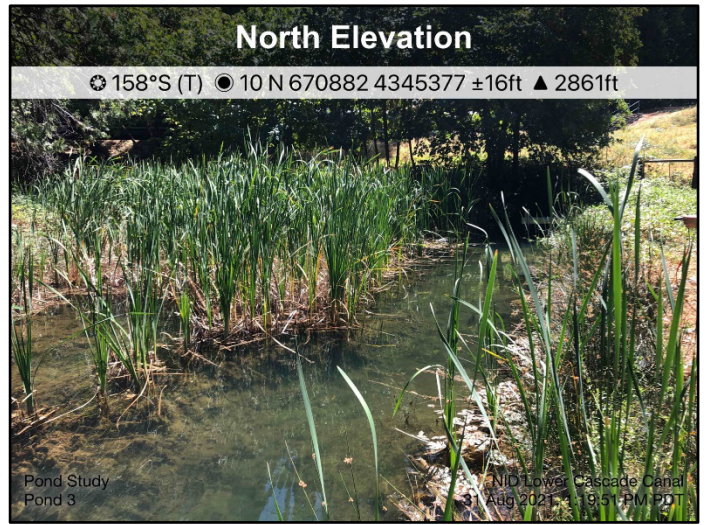
Photograph 54: 2021: DS Canal Pond 3 (reference site). Southeast facing aspect.

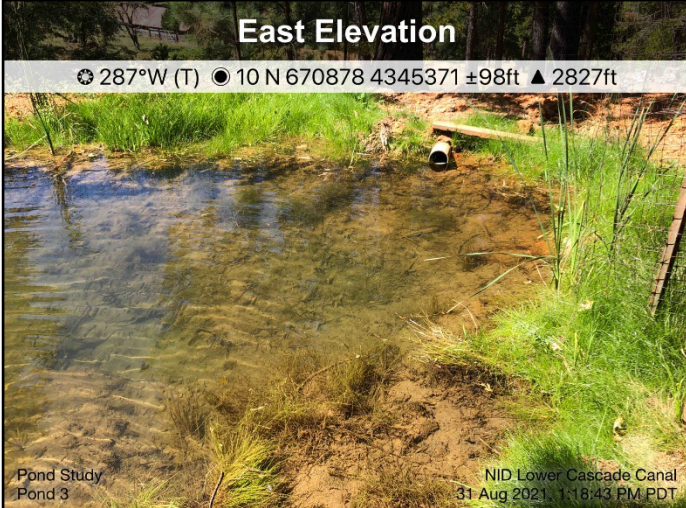
<p>East Elevation 287°W (T) 10 N 670878 4345371 ±98ft ▲ 2827ft Pond Study Pond 3 NID Lower Cascade Canal 31 Aug 2021, 1:18:43 PM PDT</p>
<p>Photograph 53: 2021: DS Canal Pond 3 (reference site). West facing aspect.</p>	<p>Photograph 54: 2021: DS Canal Pond 3 (reference site). West facing aspect. Water outlet that flows down to a lower pond not included in the Pond Study.</p>

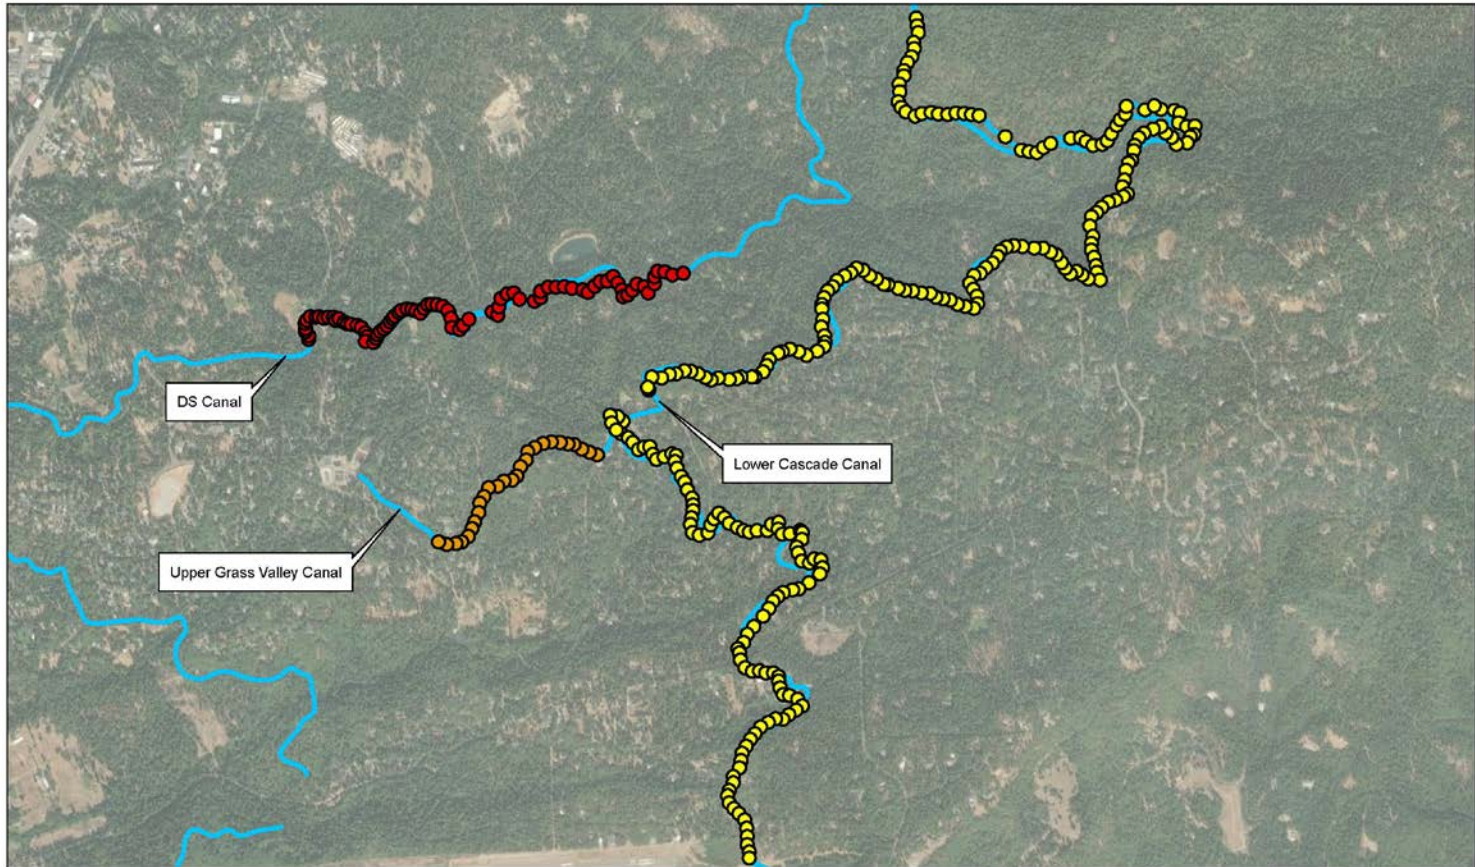
Canopy Cover Study

- NID Canal
- DS
- LCC
- UGVC
